## TEST & EVALUATION REPORT

### Shingle Rejuvenator Benchmark Life-Cycle Study

September 3, 2024

**Report For:** RoofRestor Rejuvenator  
Saskatchewan, Canada

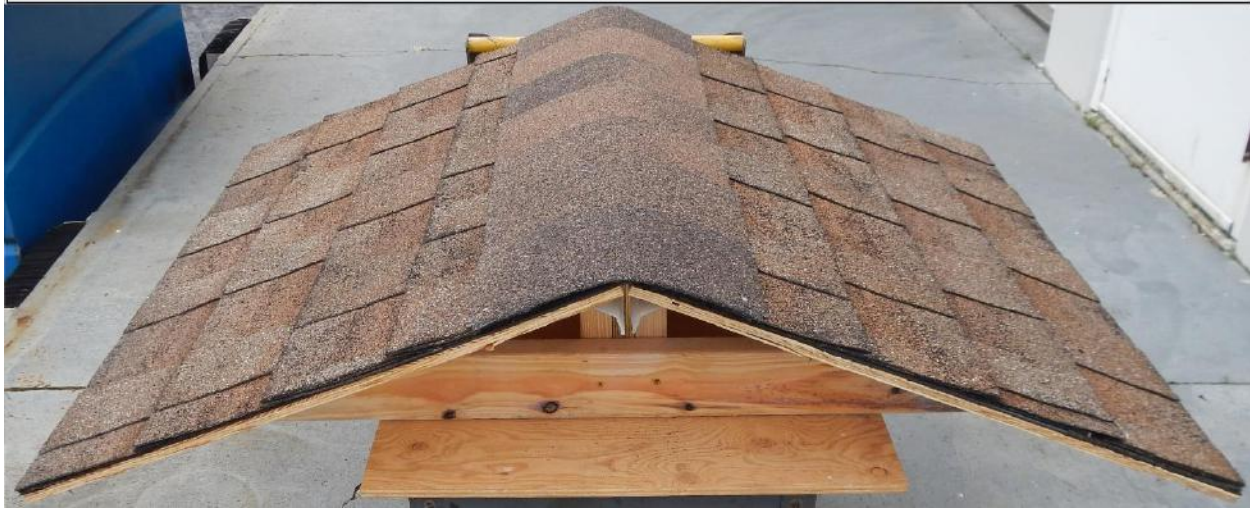
### APPENDIX A-1 (Roof Deck Construction):

#### Completed Roof Deck Before Rejuvenator Application

A type of common, commercially used ridge-cap shingles were then cut and applied to the cap of the roof deck. The cap was selected for the closest visual match to the shingles used.

The study used a miniature steep sloped roof, constructed at PRI made with commonly used stock material (2X4's, plywood, peel-n-stick underlayment, and stainless-steel roofing nails). Both slopes were roofed with the aged shingles, with one side being treated with RoofRestor rejuvenator and the other side being an un-treated roof deck. The rejuvenator was applied according the manufacturer's recommendations. See appendix for photos and details of construction

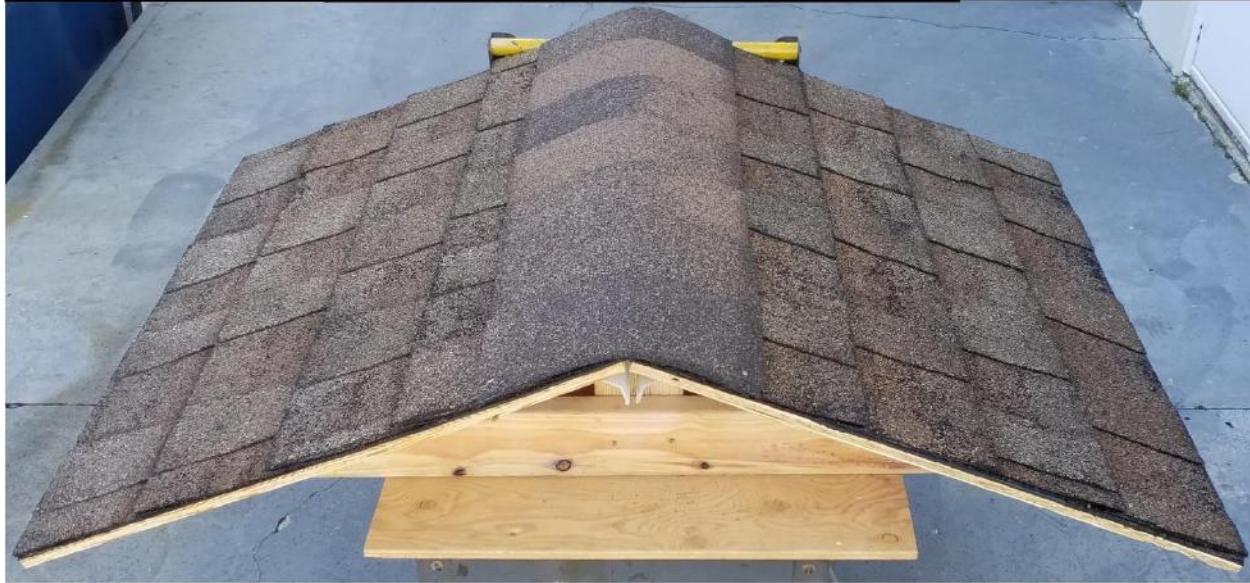
### APPENDIX A-2 (Roof Deck Construction):

### Roof Deck After Rejuvenator Application

The RoofRestor Rejuvenator was prepared and applied according to manufacturer guidelines using common garden spray bottles and allowed to cure for 24 hours:

- Manufacturer recommendations – A mixture of 70% water and 30% Rejuvenator concentrate stirred by hand to homogeneity.
- The product was applied were to one side of the roof deck at a target rate of 1 gallon per 100ft<sup>2</sup> using simple spray bottles.
- The other side was left un-treated.

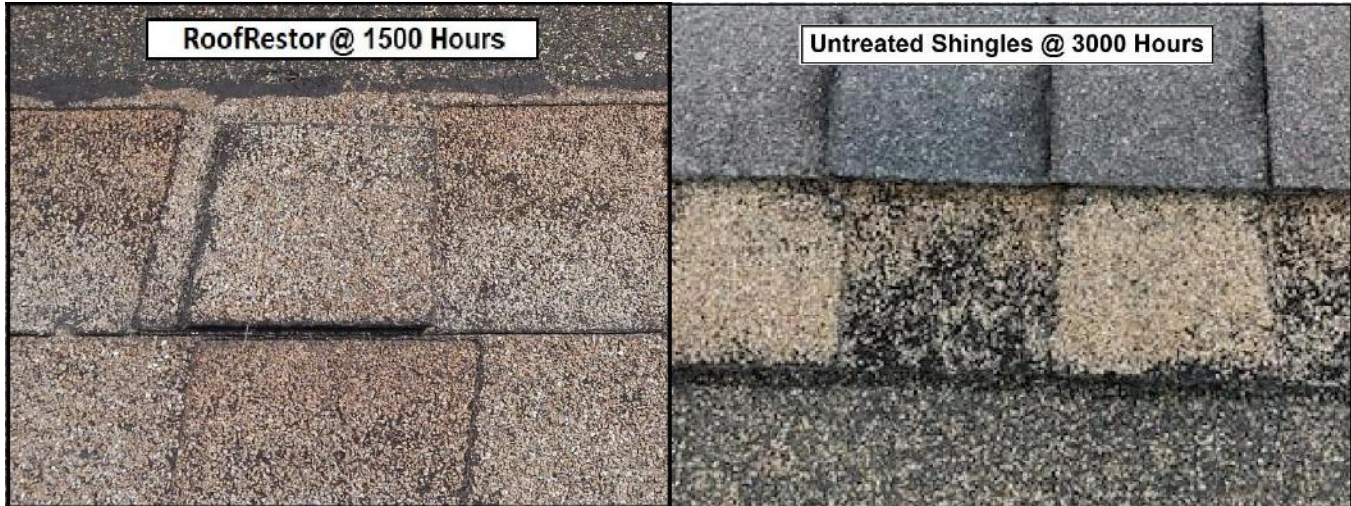
### APPENDIX A-5 (Shingle Appearance Comparison – ~3000 hours):

There is a notable difference in appearance between the untreated and treated shingles after 3000 Hours.

- Un-treated shingles show a clear increase in the roofing granules lost. (Appendix A-4/5)

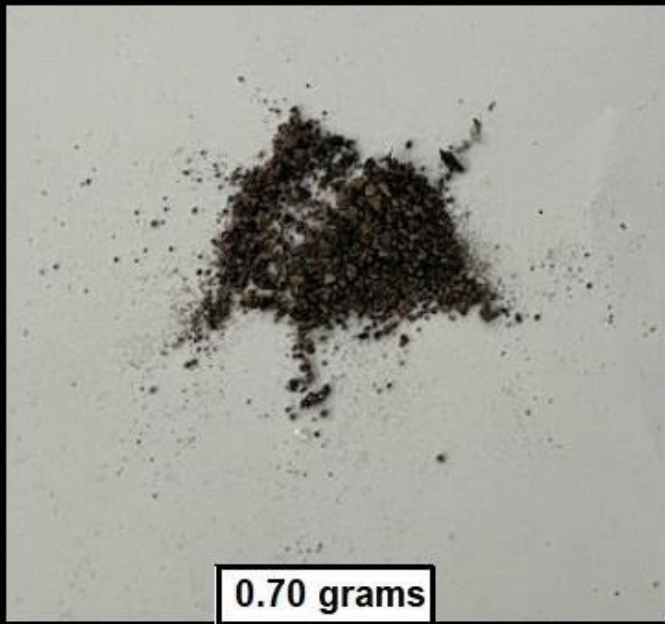
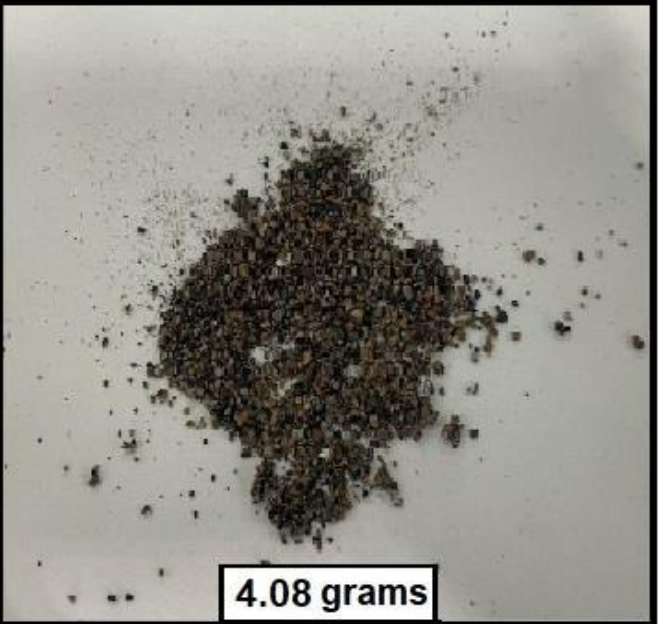
### APPENDIX A-6 (Granular Wash off Comparison – ~1500 hours):

| RoofRestor | Un-Treated Shingles |
| 0.70 grams | 4.08 grams |

Granules and particulate washed from the roof decks after 1500 hours of exposure. Particles have been filtered from the accompanying runoff water and dried for quantification.

- After 1,500 hours of exposure the mass of the collected particulate from the un-treated shingles was 4.08g compared to 0.70g for the RoofRestor' rejuvenator.
